Water Compliance Inspection Report

***NPDES
Inspection Report***

***Verallia
Saint-Gobain Containers, Inc.
Seattle, WA***

August 16th, 2012

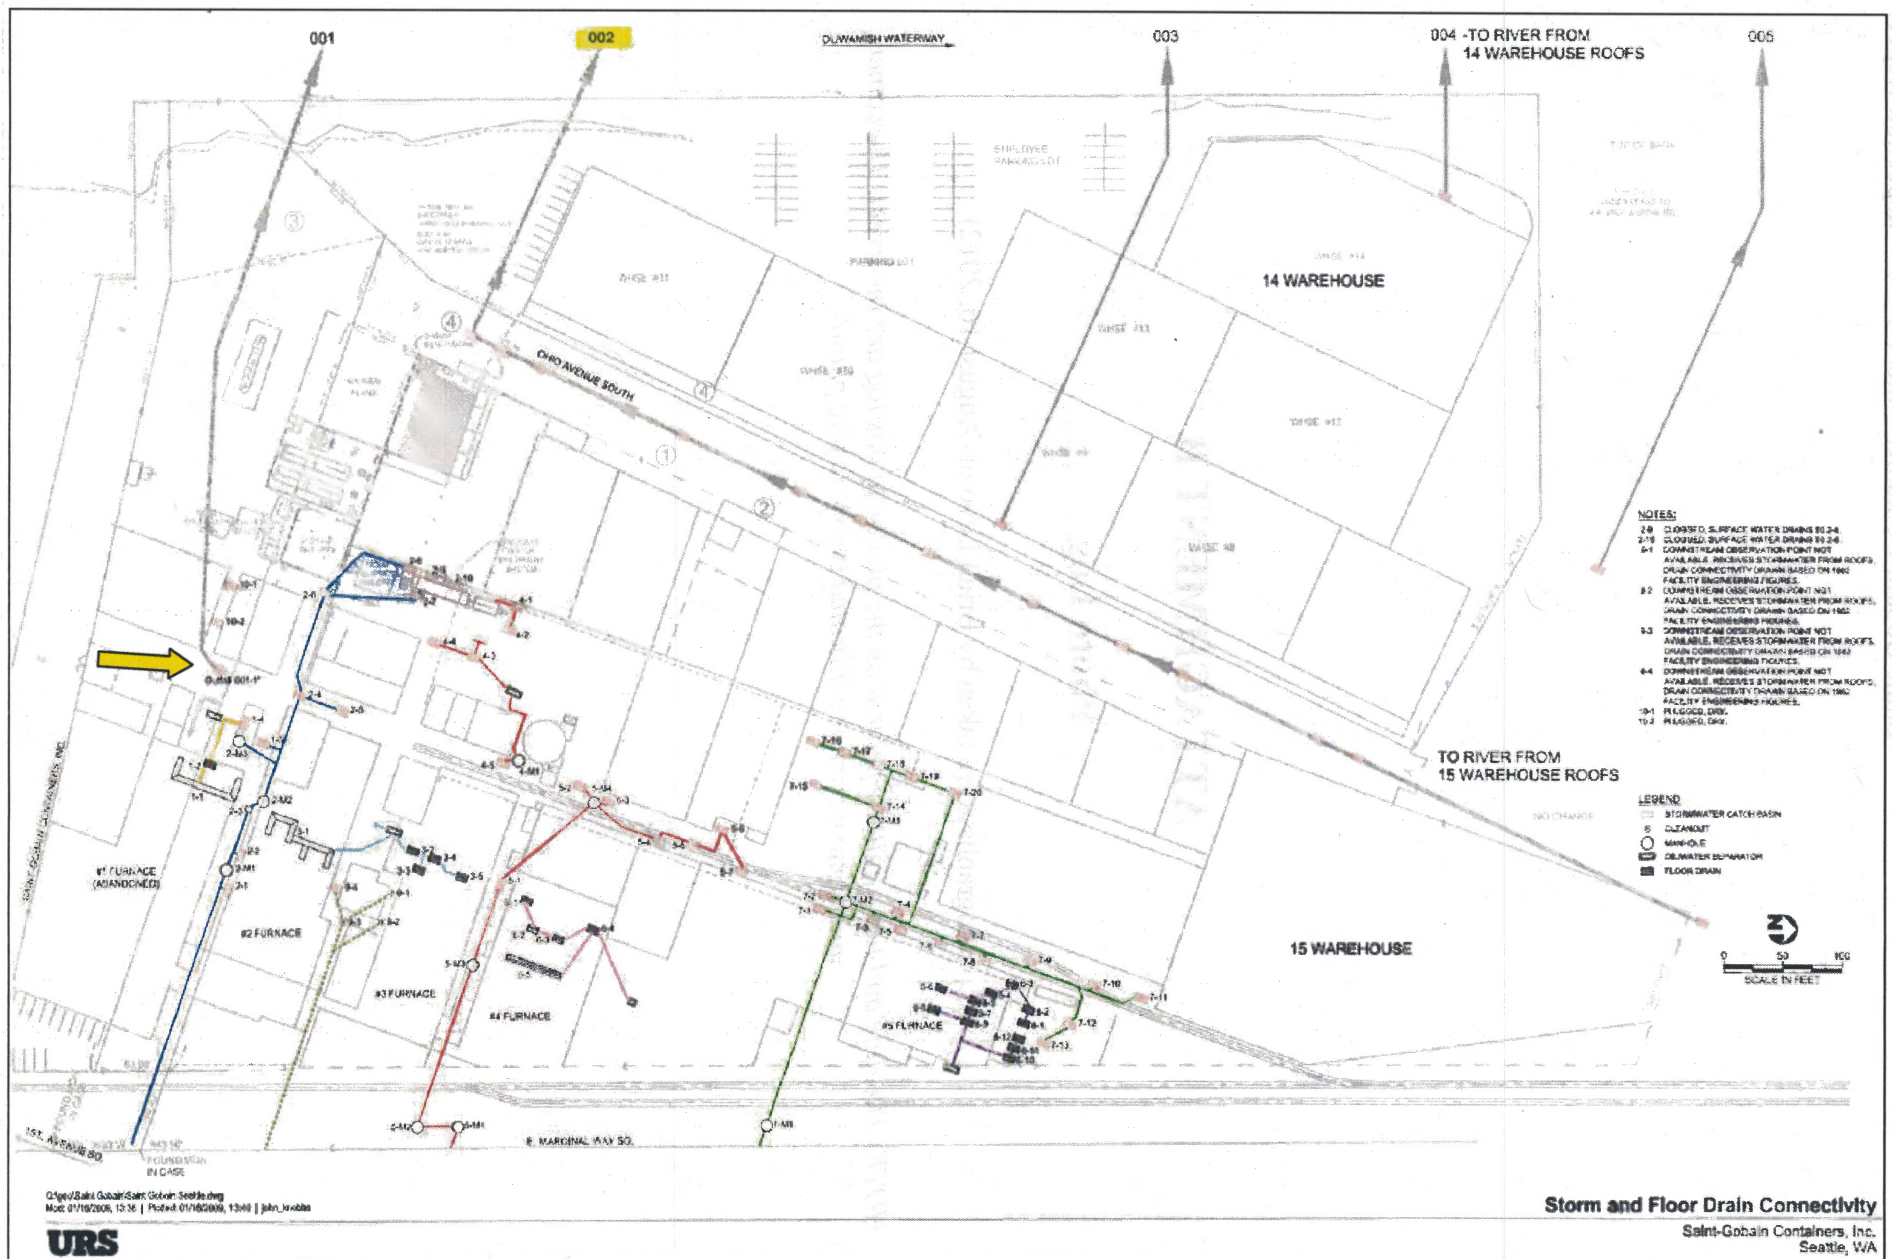
At the time of inspection, the SWPPP map did not identify the sampling location. However, the map did identify storm drain catch basins and each of the outfalls. Following the inspection Mr. Trigg sent me a digital copy of the SWPPP including a different map of the storm drain system (**Map 2, Attachment A**). This SWPPP map also does not identify the sampling location.

Map 2: Drainage map included in SGCI's 07/13/2012 SWPPP. Outfalls are numbered, but not labeled, at the top of the map. The only catch basin believed to discharge to outfall 001 is identified with a yellow arrow.

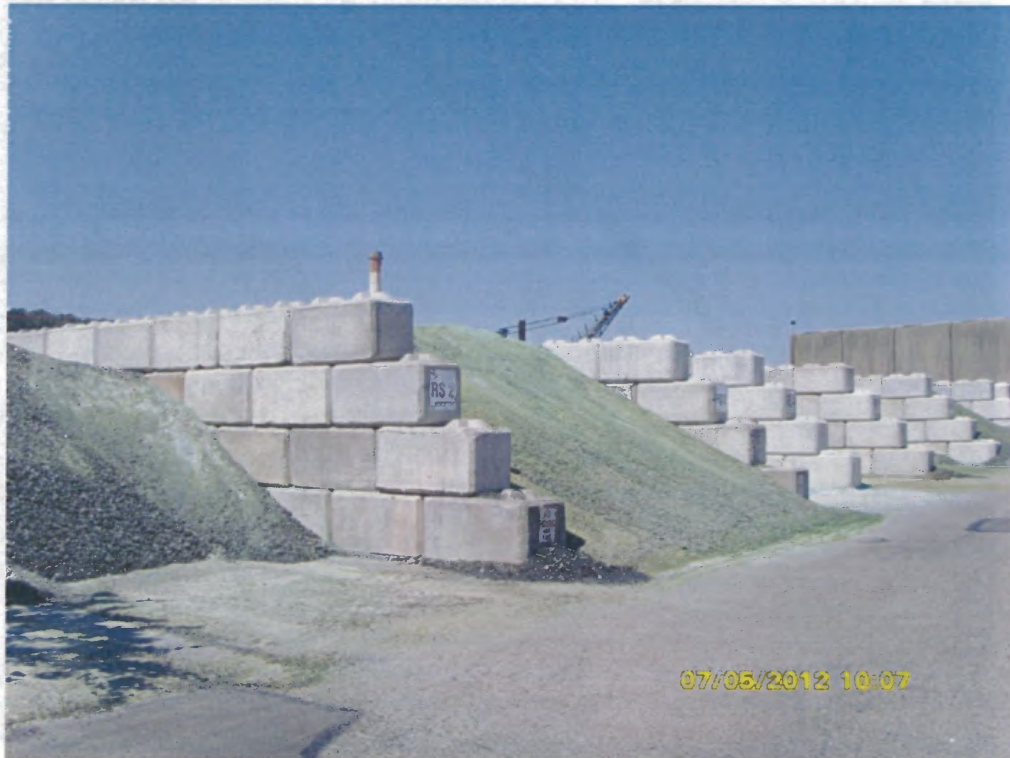
Photo 1 (SI851615): Exposed cullet piles stored at the southwestern corner of the facility near an unknown storm drain and unknown outfall. At the time of inspection pieces of cullet were littering the ground outside of the storage areas.

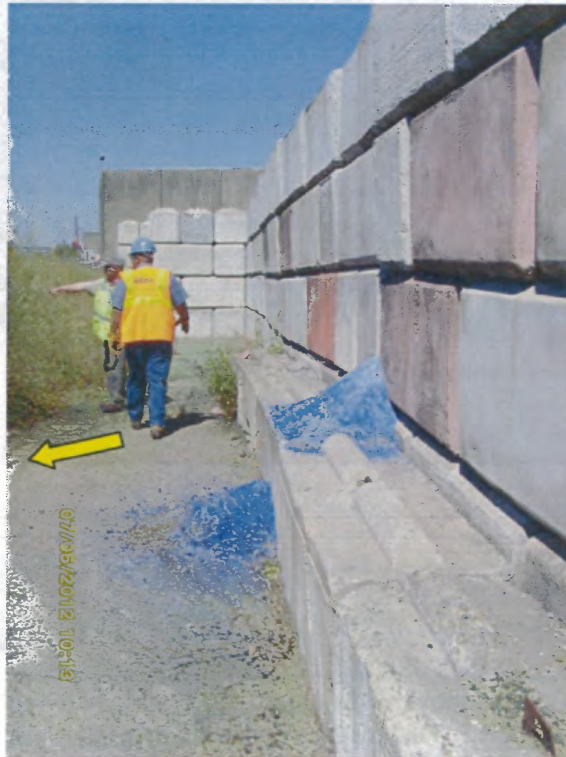
spilling out from the back of the cullet storage area, allowing cullet to be dispersed along the western side of the facility. Mr. Trigg explained that he did not believe the cullet posed a pollution hazard, but also admitted that runoff from the cullet piles had not been analyzed for pollutants.

Photo 2 (SI851617): Cullet spilled through the back of the exposed storage piles. The Duwamish River is approximately fifty feet away through some brambles and down a rocky embankment (direction of yellow arrow).

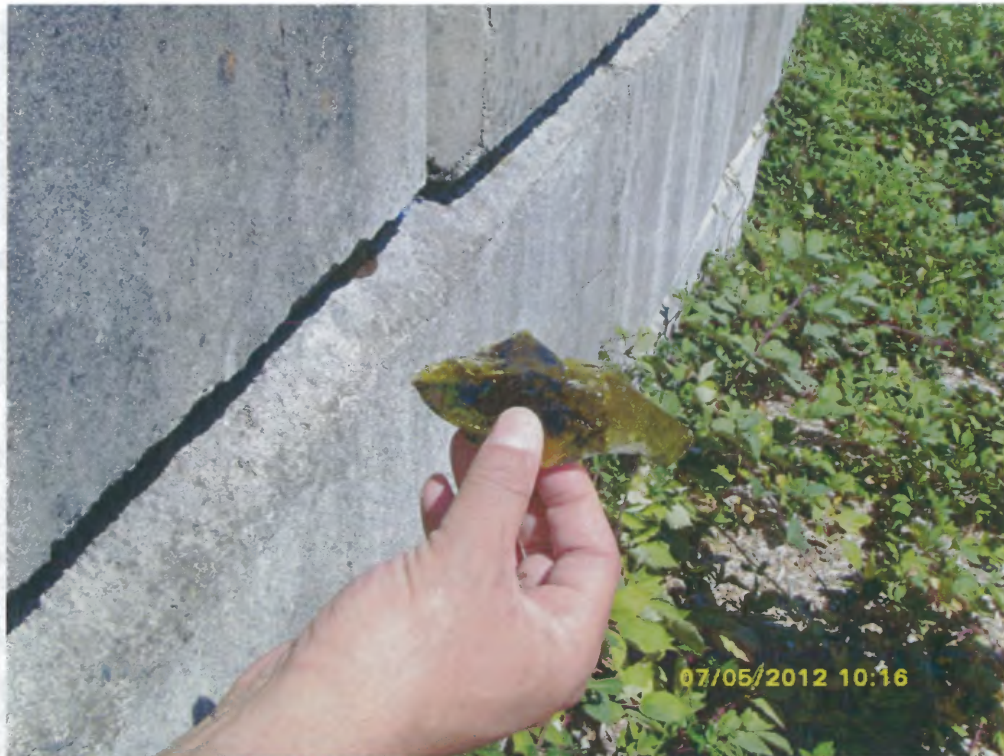
Photo 3 (SI851618): An example of a piece of cullet.

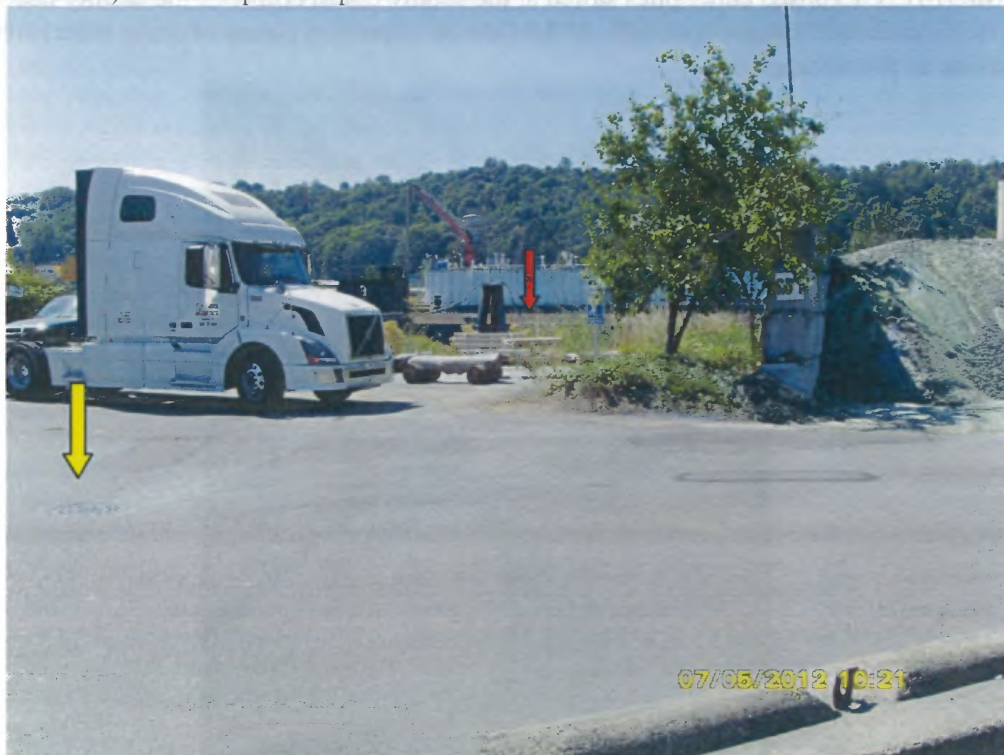
Photo 4 (SI851619): Western view showing the slope between the cullet storage pile and the unknown catch basin (yellow arrow). It appeared that drainage into the basin discharges through an unknown outfall into the Duwamish River. The approximate location of the outfall is shown by a red arrow in the background of the photo.

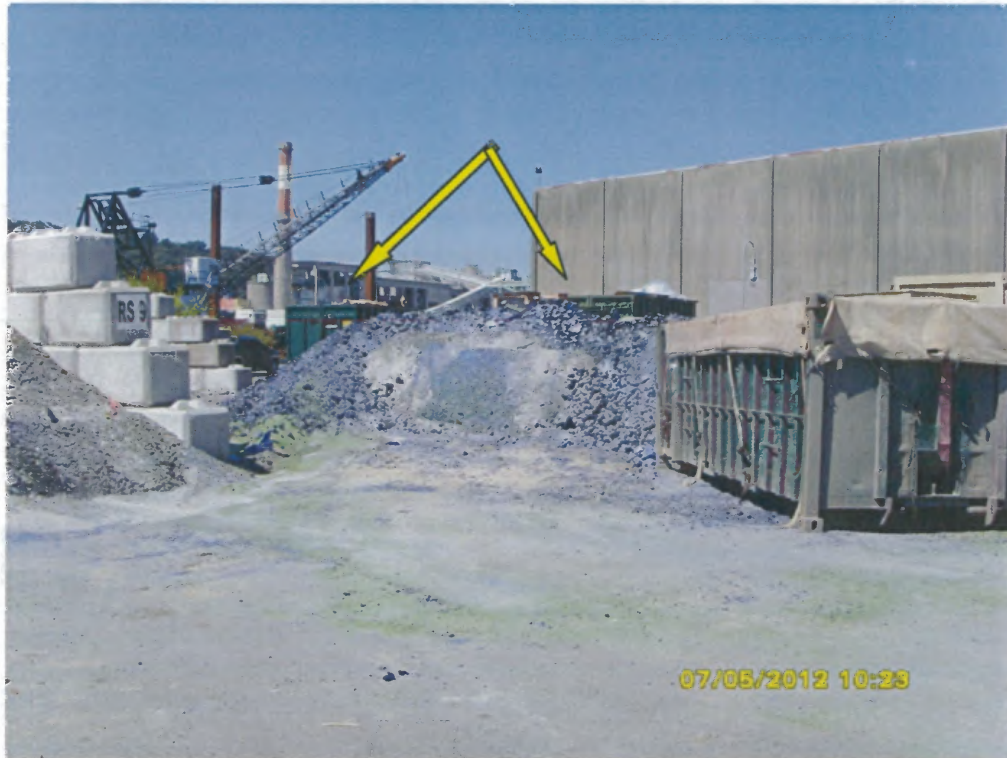
Immediately north of the cullet storage area were two dumpsters left uncovered at the time of inspection (**Photos 5 & 6**). The dumpsters appeared to contain wood, cardboard, tires, and pieces of metal.

Photo 5 (SI851620): Northwest view of an exposed cullet pile in the cullet storage area. At the time of inspection pieces of cullet were littering the ground outside of the storage areas. Two uncovered dumpsters are located behind the cullet pile (yellow arrows).

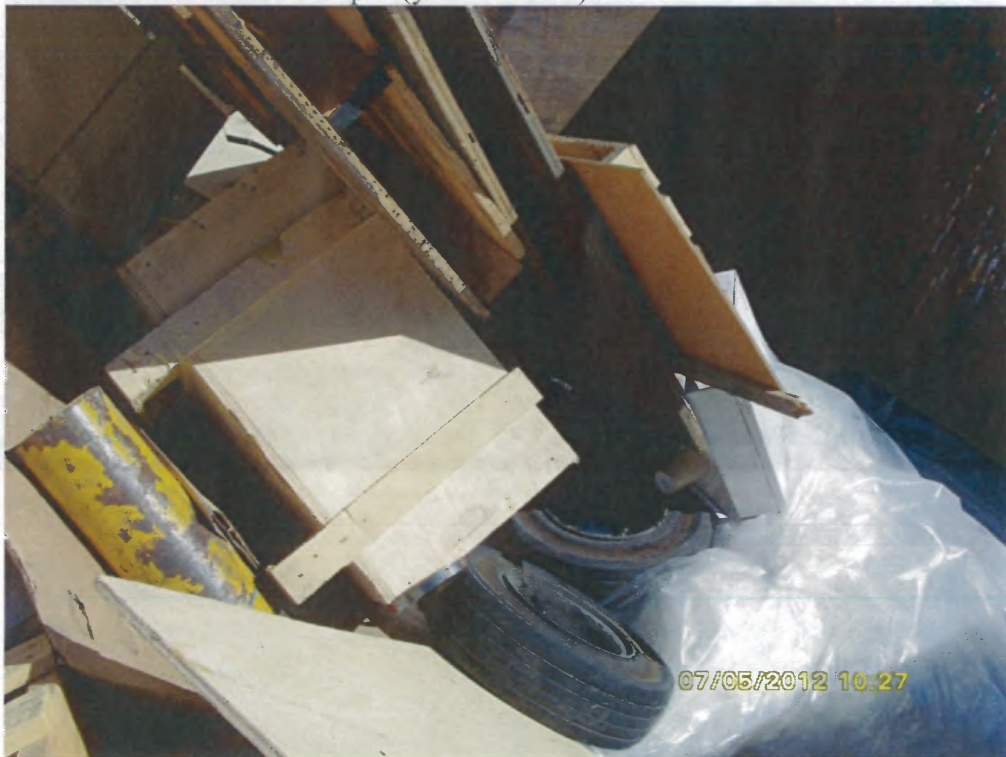
Photo 6 (SI851623): The inside of one of the two uncovered dumpsters located near the cullet storage area.

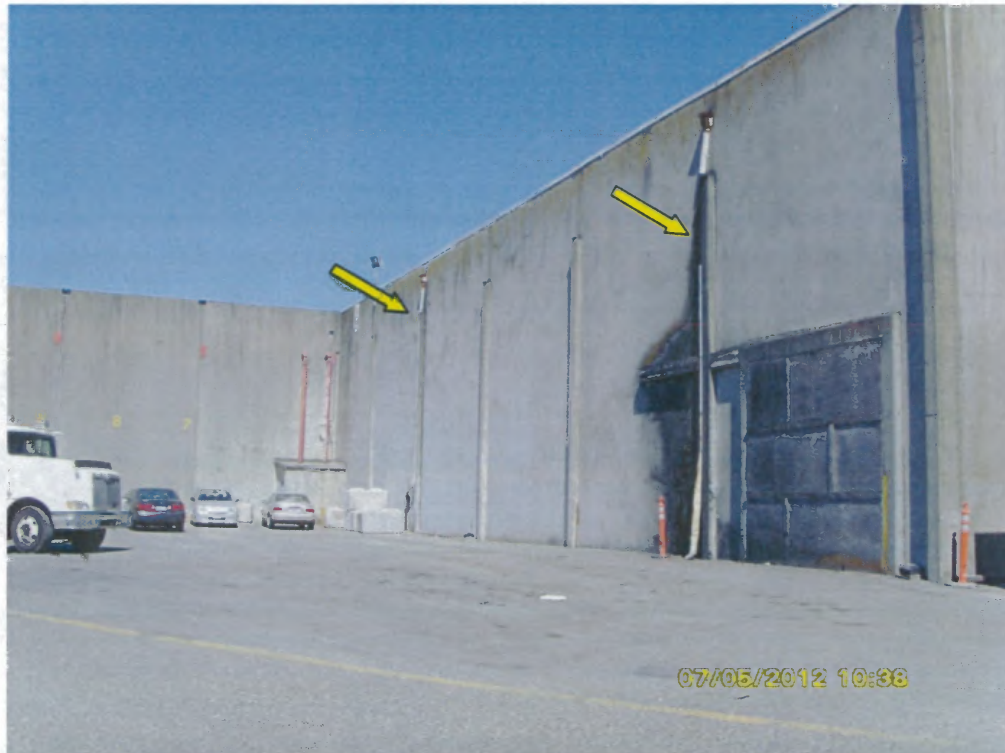
Photo 7 (SI851625): Northeastern view of the western side of the facility showing two rusted roof drainage pipes (yellow arrows). The pipe furthest to the right appeared to be missing a large connecting portion at the top.

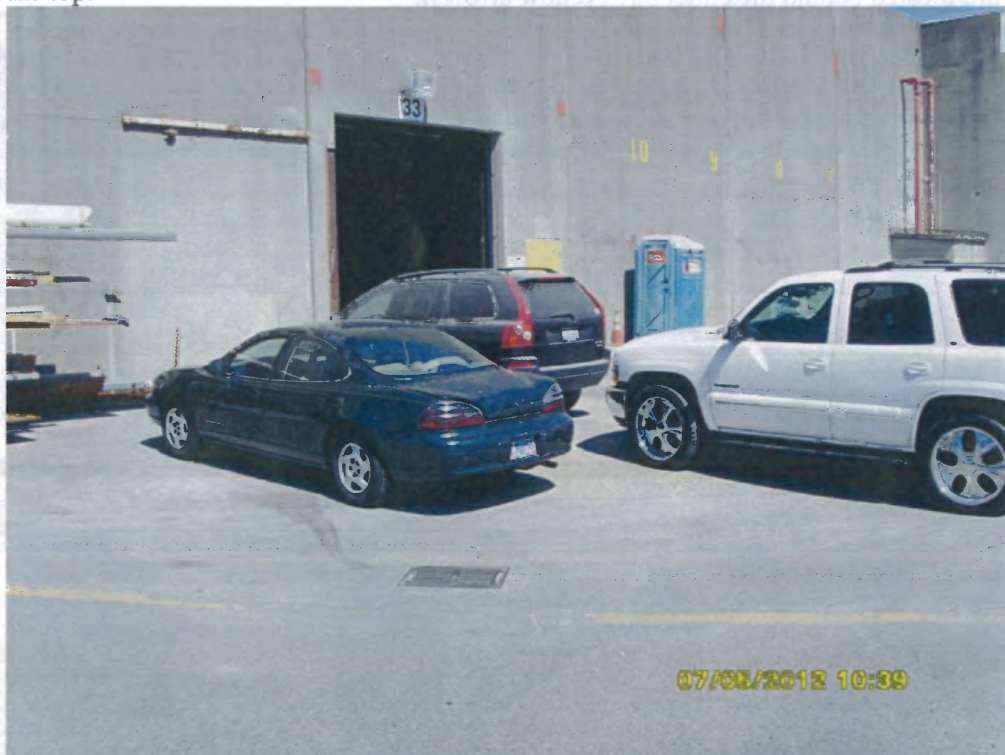
Mr. Trigg informed us that the warehouse at the northwestern corner of the facility closest to outfalls 003 and 004 was the one being leased by the company eCullet. We observed that there was a storm drain catch basin on the south end of this building that Mr. Trigg believed flows to outfall 003 (**Photo 8**). We noted that the roof drains along the west side of the eCullet building were newer and did not appear to be damaged (**Photo 9**). Along the northwestern edge of the SGCI property and the northern end of the eCullet warehouse, there appeared to be white particulates or dust covering the road and all other outdoor surfaces at the time of inspection. It appeared that the particulates were originating from either J.A. Jack & Sons (company north of SGCI, **Photo 10**) or a baghouse being operated by eCullet located on the outside of the north side of their building (**Photo 11**). I asked Mr. Trigg what the baghouse was used for and he explained that he thought the baghouse captured particulates associated with cullet crushing and processing being performed by eCullet.

Photo 8 (SI851627): Northeastern view of a storm drain catch basin on the south end of the eCullet warehouse. This drain appeared to flow to outfall 003.

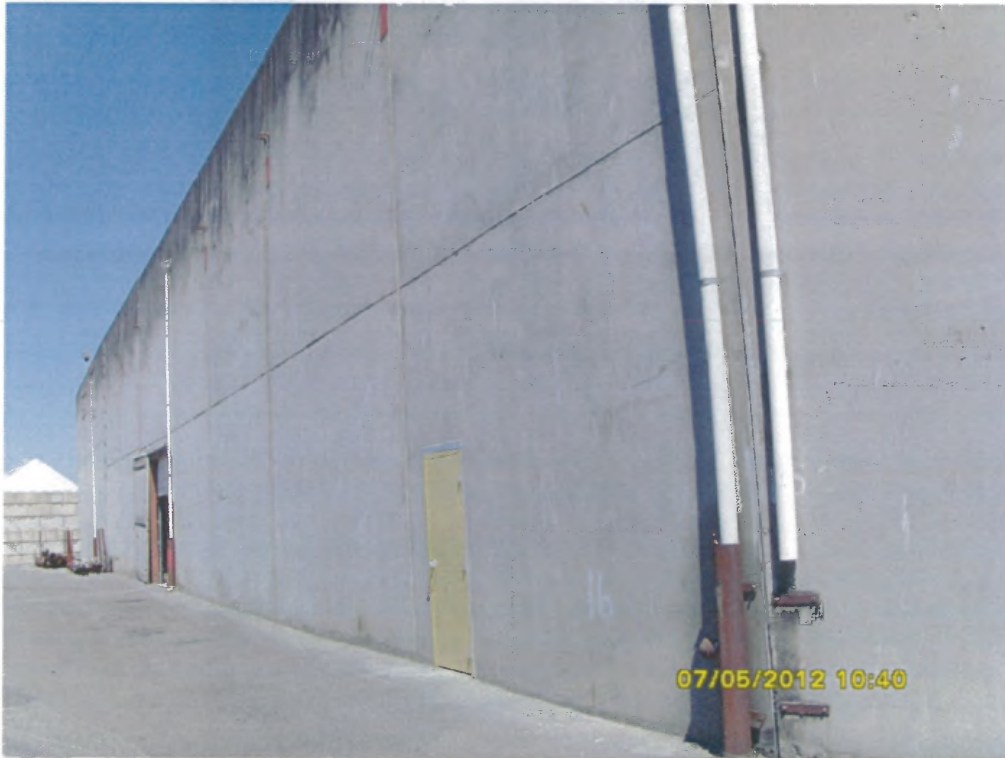
Photo 9 (SI851628): Drainage pipes on the west side of the eCullet warehouse. These pipes appear to be in better condition than most of the other roof drainage pipes along the west side of SGCI.

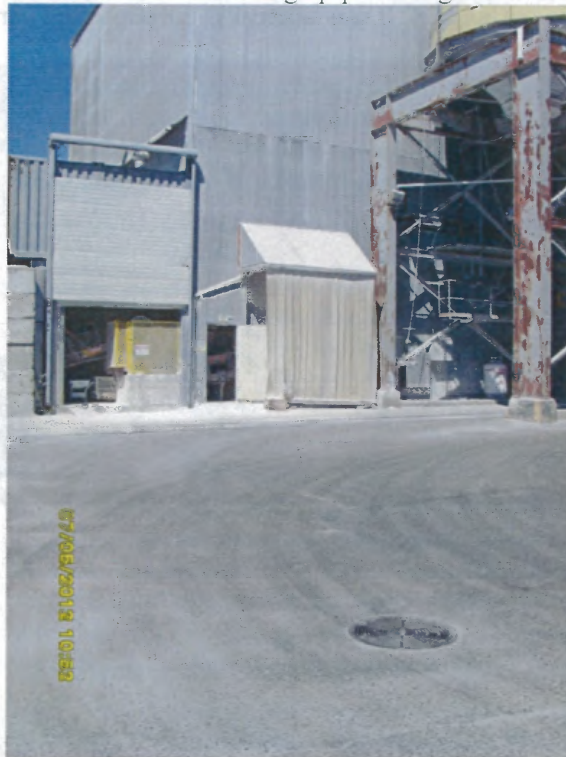
The SWPPP does not mention the operations being conducted by eCullet Inc. At the time of inspection we observed that eCullet was operating a baghouse on the north side of the building they lease (**Photos 10 & 11**). There were also particulates blanketing the outdoor surfaces along the northwestern border of SGCI. These particulates could have been associated with the baghouse. Mr. Trigg claimed that SGCI is not responsible for drainage from eCullet operations including the exposed bag house. However, Mr. Trigg

Photo 10 (SI851631): Northern view of J.A. Jack & Sons, the business that shares the northern boundary of Saint-Gobain Containers. According to the facility, the drain shown falls on J.A. Jack & Sons property. Notice the deposited particulates blanketing the area.

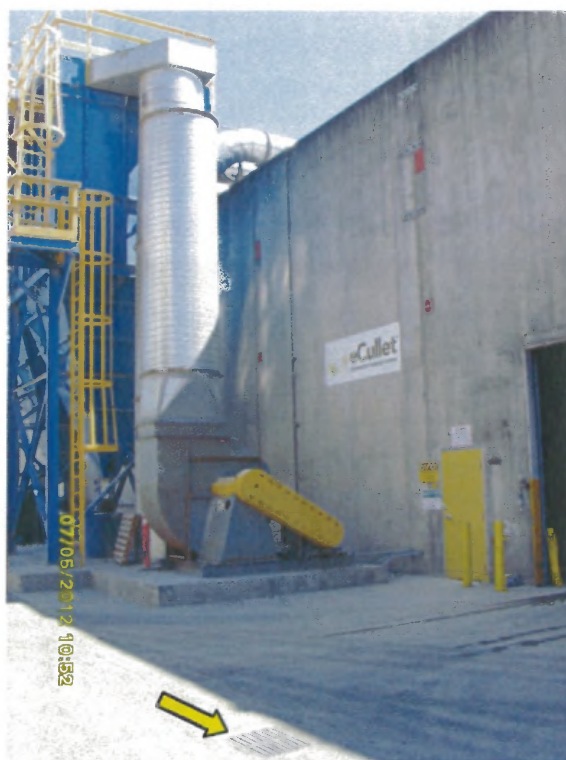
Photo 11 (SI851632): Southeastern view of the baghouse on the north side of the eCullet warehouse. Notice the deposited particulates blanketing the area and the location of a storm drain (yellow arrow). This drain appeared to flow to outfall 004. It was unclear if the deposited particulates were a result of eCullet or J.A. Jack & Sons operations.

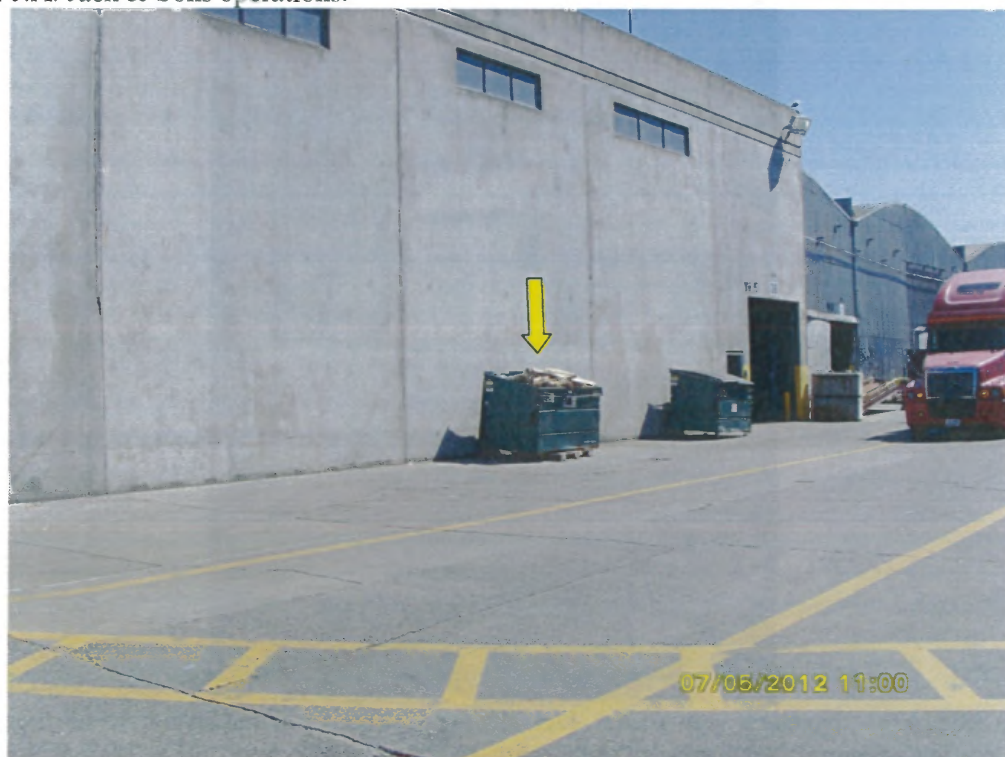
At the north end of Ohio Ave we found a third uncovered dumpster (**Photo 12**). At the time of the inspection the dumpster lid was pinned behind it against the wall. The dumpster wheels were also damaged and did not look like it could be moved easily. Mr. Trigg explained that it was probably damaged from a forklift collision. The dumpster contained mostly wood and cardboard. We also saw a fourth uncovered dumpster located on Ohio Ave that contained scrap metal (**Photo 13**).

Photo 12 (SI851637): Uncovered dumpster on the north end of Ohio Ave (yellow arrow). The lid appeared to be pinned against the wall and the rolling wheels damaged at the time of inspection.

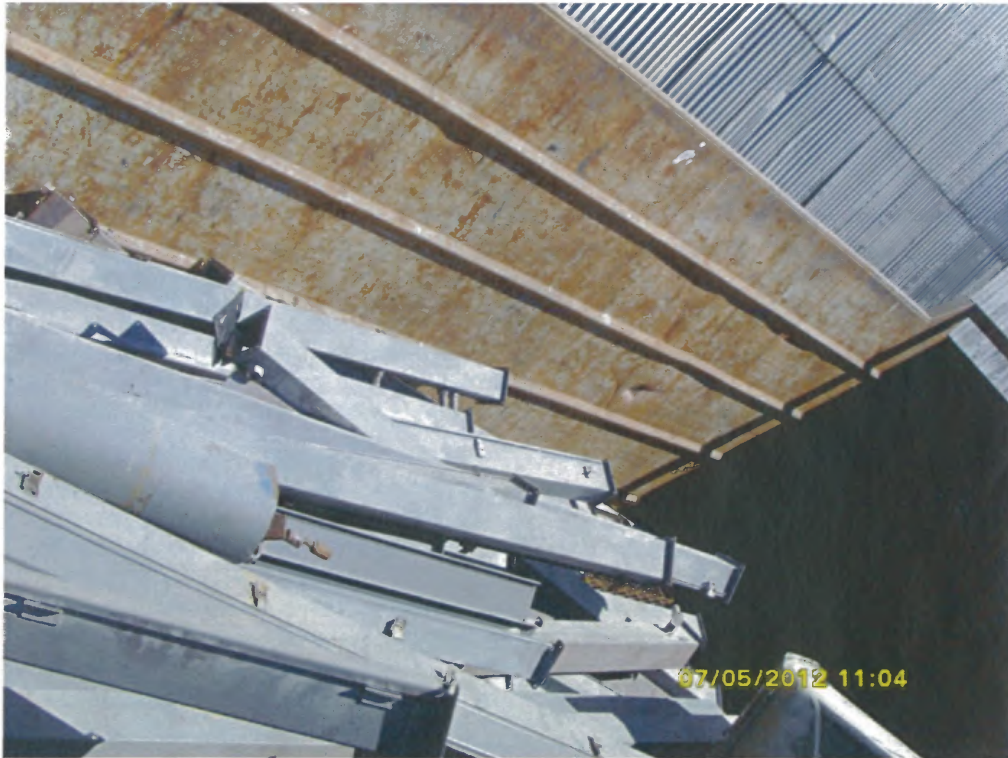
Photo 13 (SI851639): View of an uncovered metal scraps dumpster located on Ohio Ave.

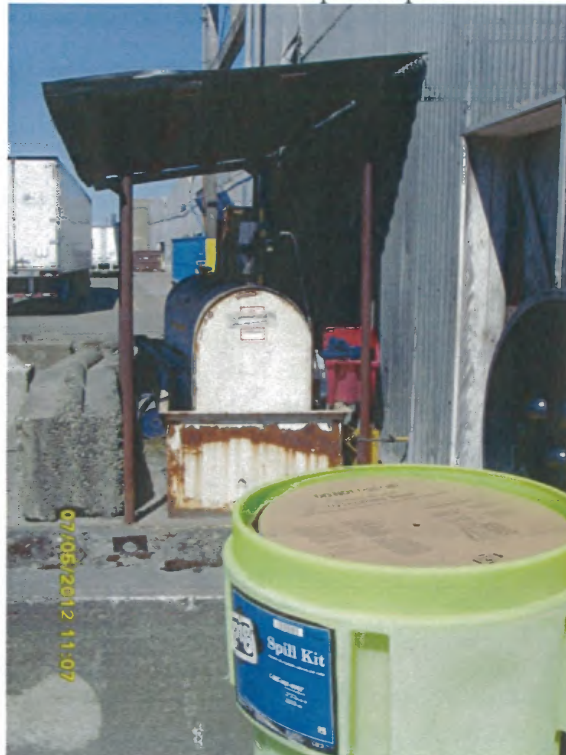
Photo 14 (SI851641): Spill kit (green barrel) located near a petroleum storage tank on Ohio Ave.

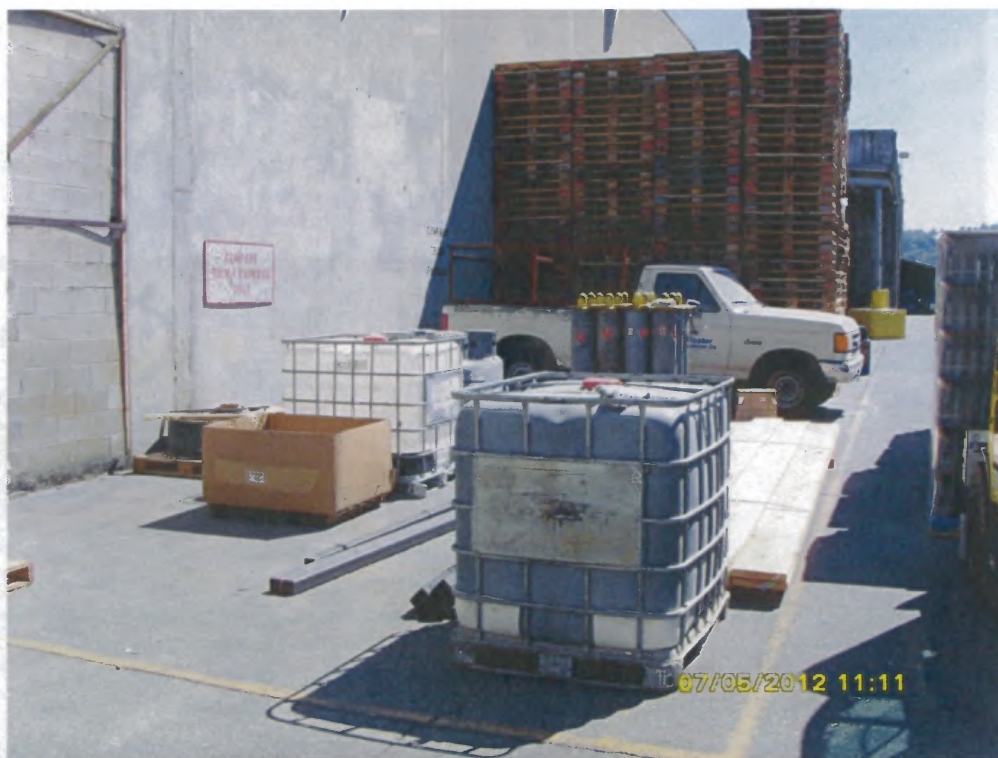
Photo 15 (SI851642): Two uncovered totes being stored on Ohio Ave without secondary containment. According to their labels, one was filled with glass mold (tote in foreground) and the other with bonding adhesives (tote in background).

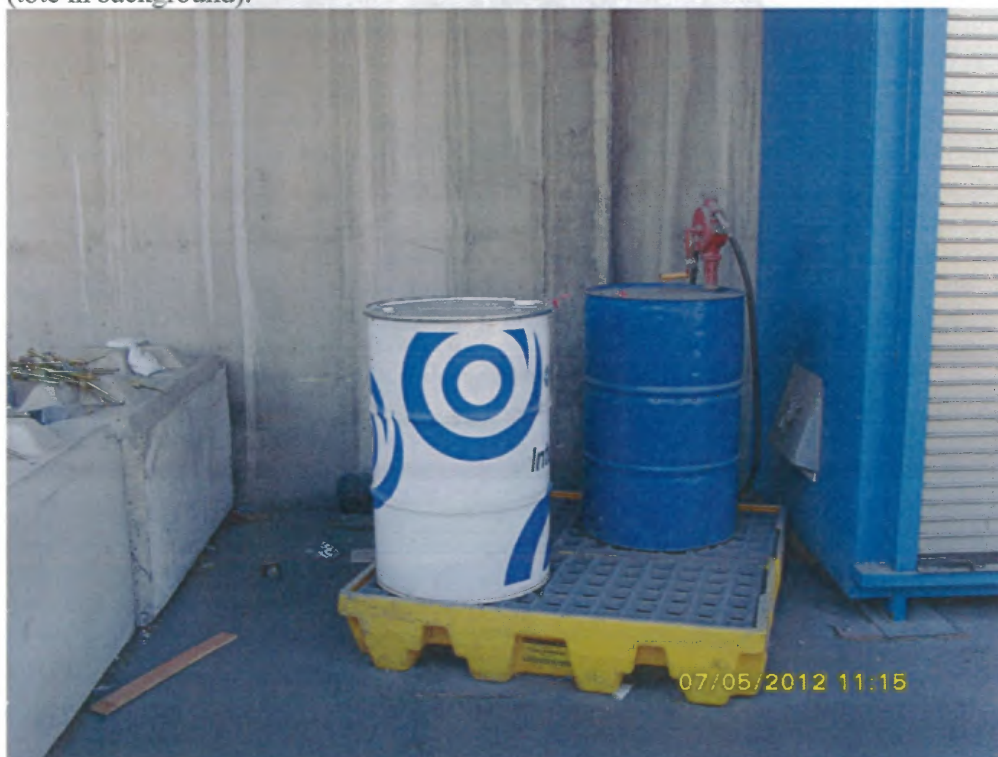
Photo 16 (SI851646): Mold lubricant (left) and kerosene (right) barrels stored undercover and on a secondary containment pad on Ohio Ave.

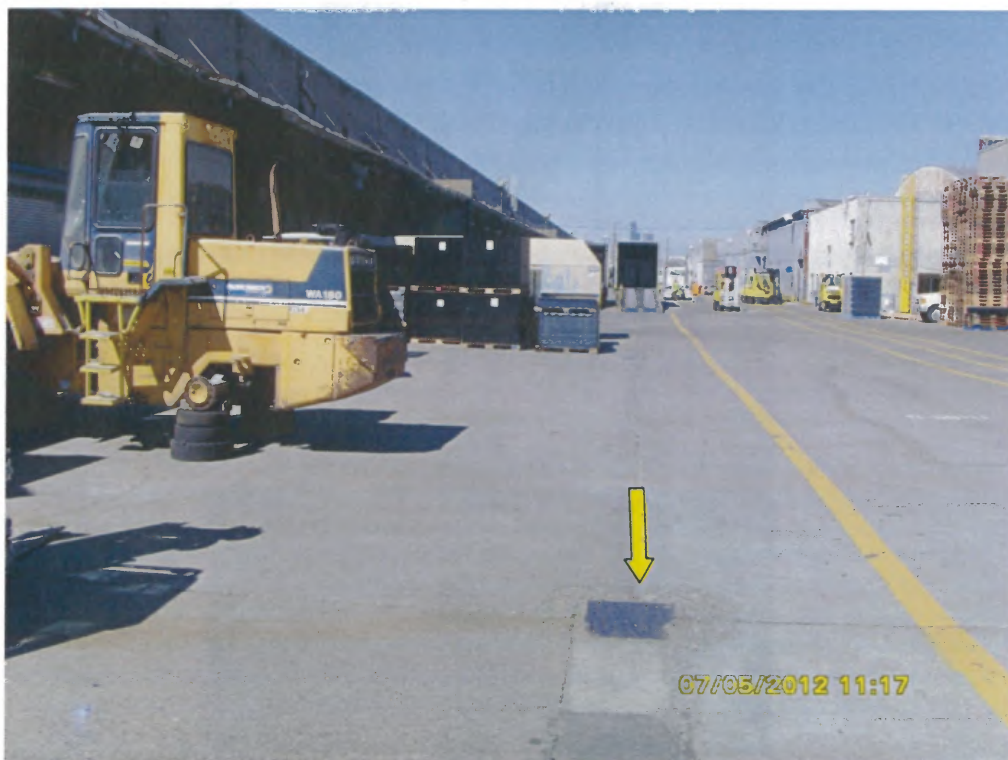
Photo 17 (SI851648): Northern view of Ohio Ave showing the proximity of an immobilized front loader to the nearest storm drain. According to Mr. Trigg, all of the drains along Ohio Ave drain to outfall 002.

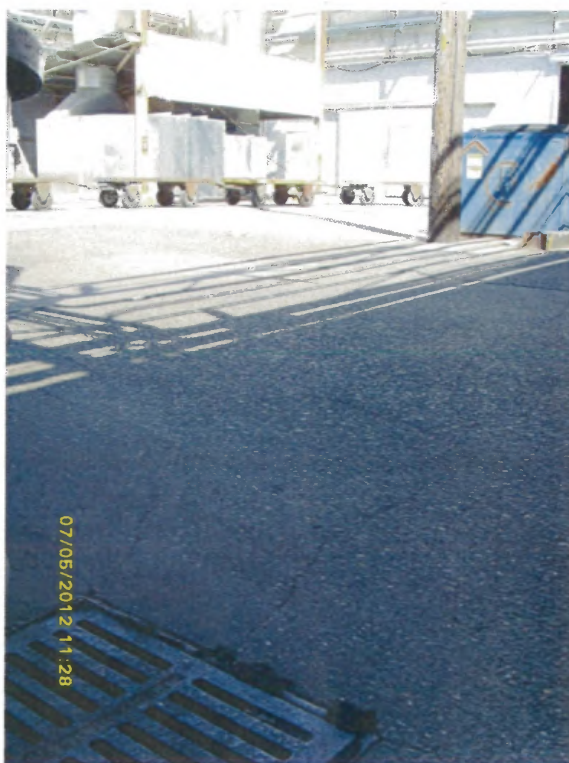
Photo 18 (SI851649): Northeastern view of the storm drain believed to drain to outfall 001. GPS point #105 was taken from this location.

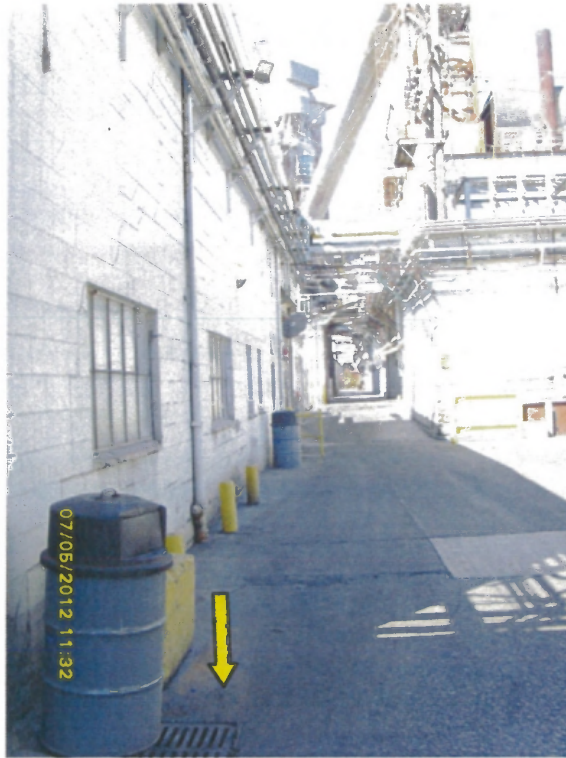
Photo 19 (SI851650): Northern view of the storm drain believed to drain to outfall 001. GPS point #105 was taken from this location (yellow arrow).
